# » Grid Incident in Czech Republic on 4 July 2025

ICS Investigation Expert Panel  
Final Report

26 June 2026

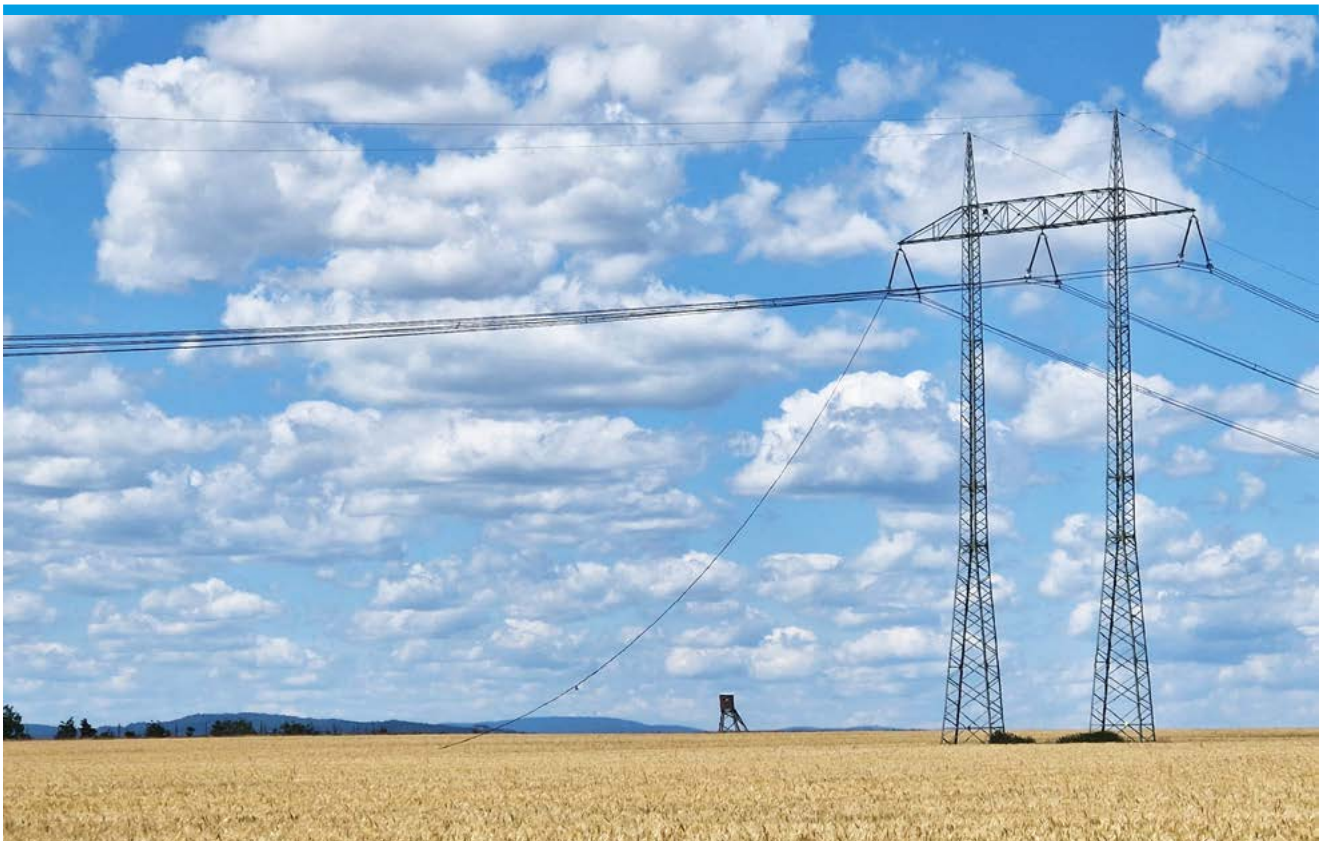
Figure 3.25: Photo of the fallen conductor

The fault was ultimately located 14 km from the HRA4 substation. The fault was switched off in 81 ms.

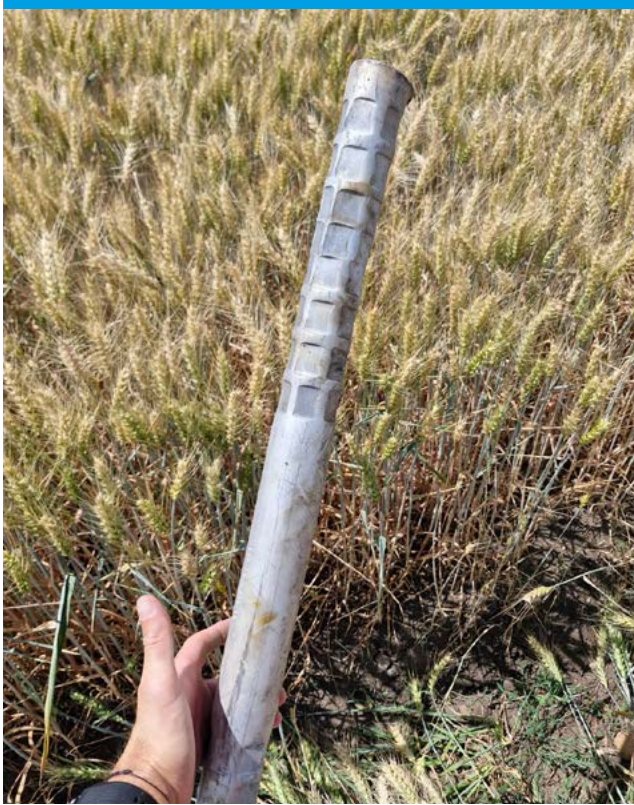
Figure 6.1: Photo of the tensile coupling

The unsuccessful auto-reclosure of V411 in phase L2 was caused by a wire break. After further examination and analysis by an expert institute, it was found that the tensile coupling had an insufficiently tight connection at the aluminium part of the conductor. Ultimately, the rope at the coupling broke, and the conductor fell. The Expert Panel was unable to determine the exact reason due to which the repair procedure resulted in an insufficiently tight tensile coupling. The Expert Panel issues a related recommendation R1 on quality assurance for works on the transmission network.

- » 1 // R1 – Strengthen verification and quality assurance for works on the transmission network, with particular focus on emergency repairs and works affecting the mechanical integrity of primary equipment.
