# » Grid Incident in Czech Republic on 4 July 2025

ICS Investigation Expert Panel  
Final Report

26 June 2026

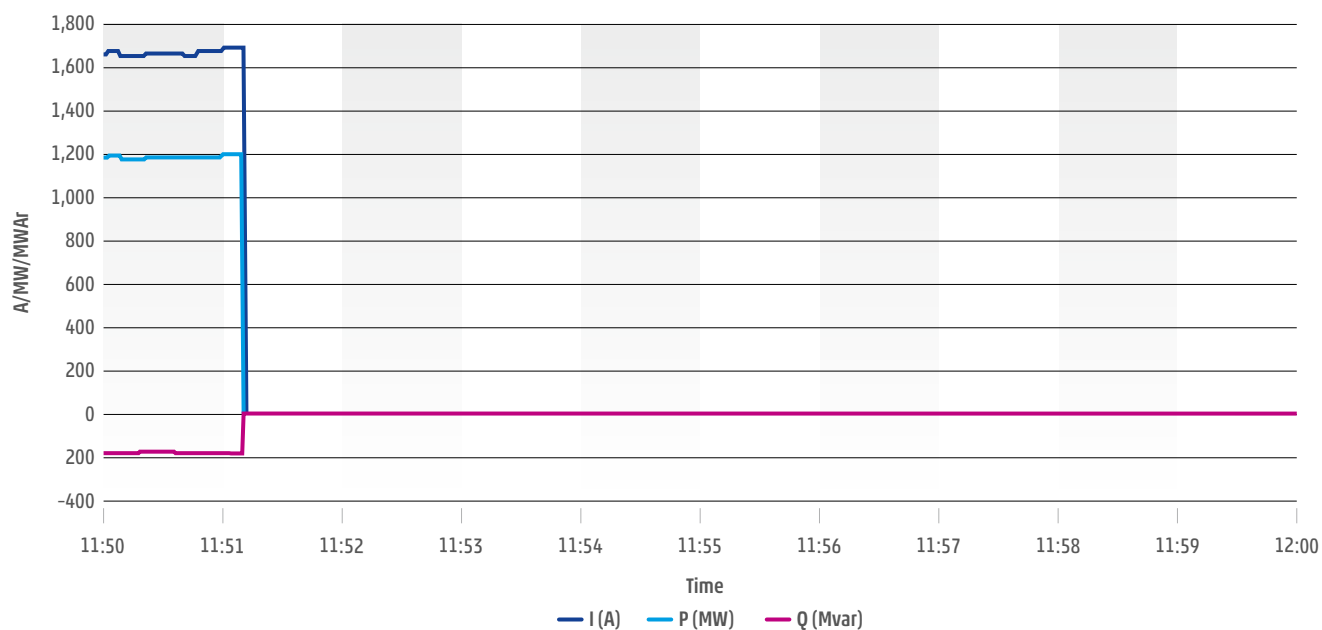
Figure 3.3: Current, active power and reactive power on Výškov line V411

Figure 3.3 to Figure 3.6 show active and reactive power flow and current on the element supplying the affected area for the period from 11:50 to 12:00.

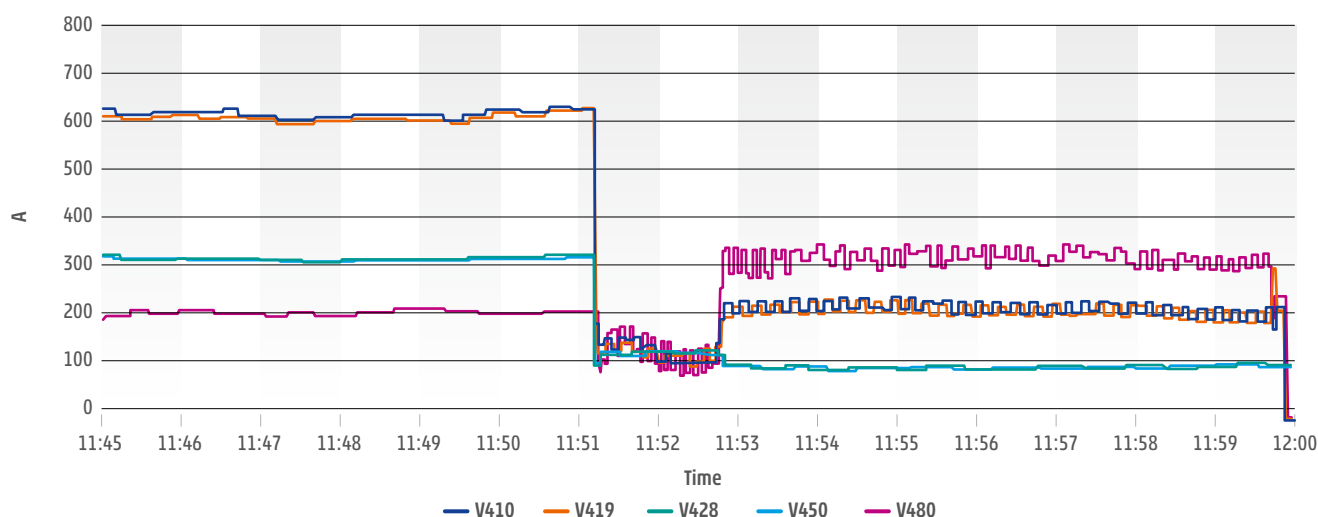
Figure 3.7: Flows on lines in the Výškov substation<sup>18</sup>

<sup>18</sup> Oscillations of active power on lines V480, V410 and V419 were caused by power oscillations on units 4 and 6 of TPP Ledvice. These were caused by setting (0 %) of the droop speed control mode of unit 4 of TPP Ledvice.

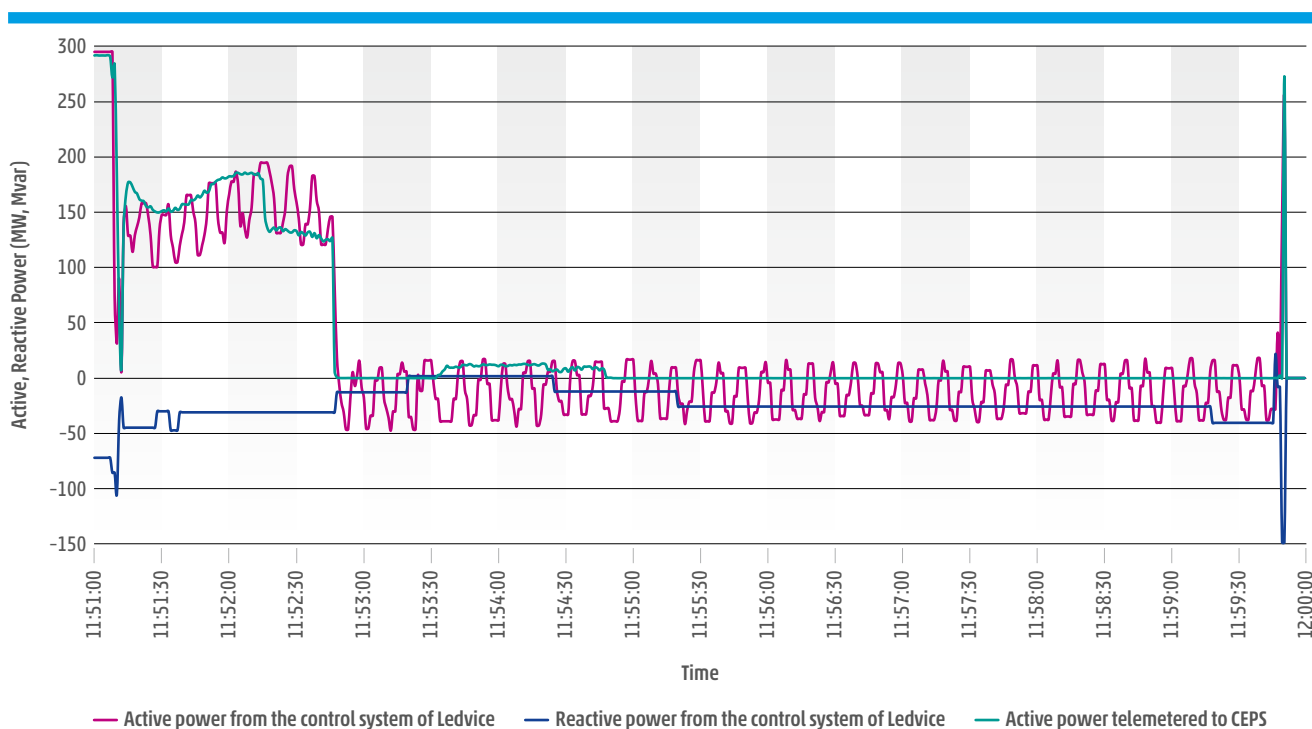
Figure 3.10: Trend of power output at generator terminals of ELED unit 6 from 11:51 to 12:00

The following series of graphs illustrates the dynamic behaviour of TPP Ledvice unit 6. The graph of active power output shows periodic oscillations for unit 6 at TPP Ledvice. Such oscillations are not present in the telemetered active power data transmitted to the ČEPS dispatching control system.

According to the statement from TPP Ledvice, at 11:51:46, a boiler outage occurred due to the activation of protection triggered by a high-temperature steam signal behind the high-pressure bypass stations. This was caused by an unforeseen technical fault in one of the high-pressure steam temperature control valves in the turbine bypasses steam piping. The valve failed to open due to an actuator motor malfunction, which was specifically caused by a defective relay.

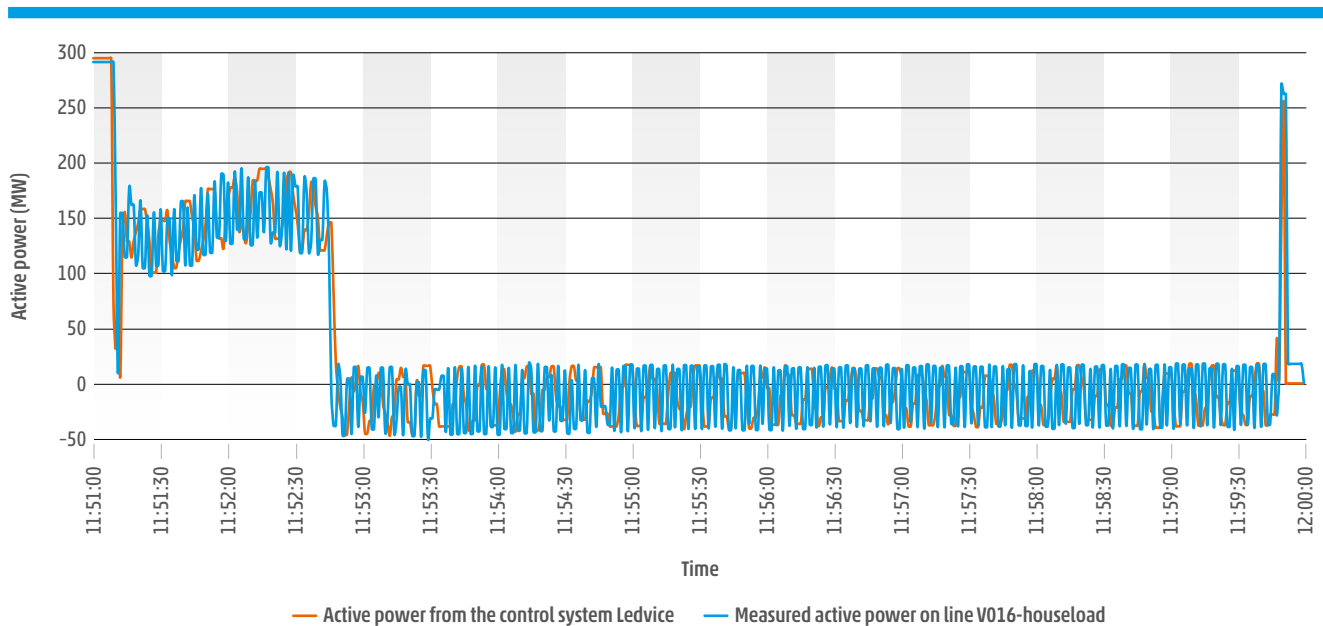
Figure 3.11: Comparison of the active power trend of the generator with the measurement on line V016 adjusted for the house load of ELED from 11:51 to 12:00

For comparison, Figure 3.11 shows measurements from the control system of unit 6 and line V016. The measurement on line V016 is adjusted for the power plant house load.

The graph clearly shows that the measurements overlap, and the line measurement also indicates oscillations (even with a shorter period) in the active power of generator unit 6.

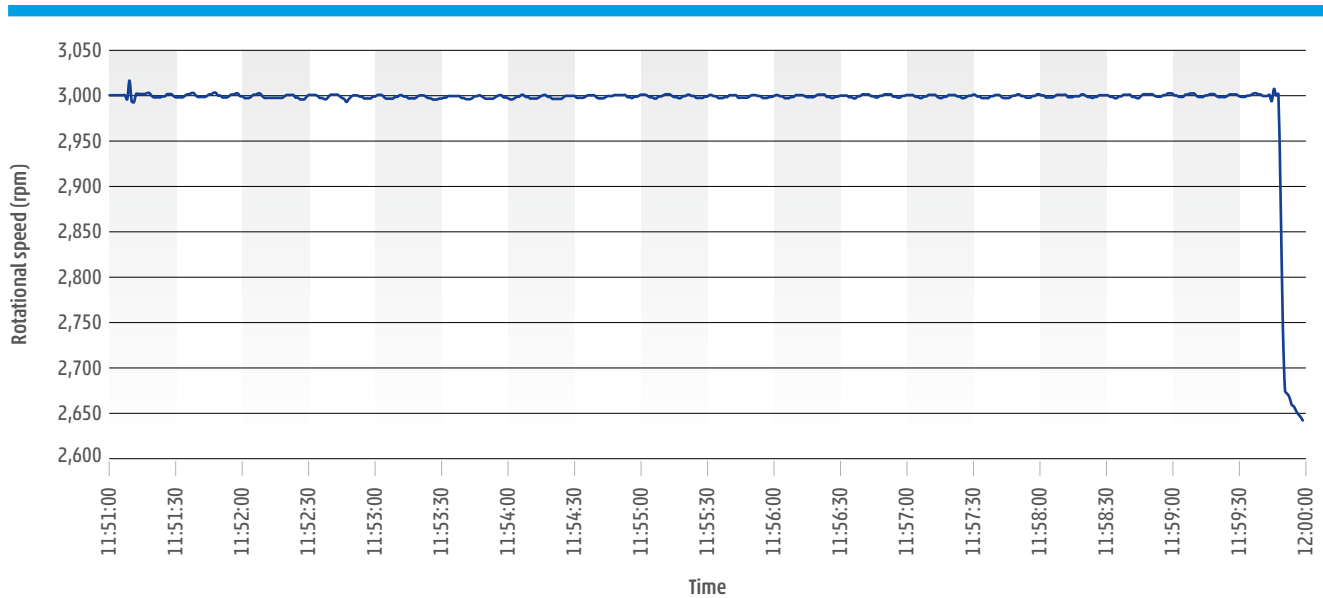
Figure 3.12: Trend of measured turbogenerator speed of ELED unit 6 from 11:51 to 12:00

The following graphs show the turbogenerator speed profile at TPP Ledvice unit 6. Figure 3.12 displays the period from 11:51 to 12:00, capturing both the V411 outage event and the subsequent frequency collapse in the affected part of the grid. The graph also shows that even after the boiler outage, the generator remained synchronised with the grid (i.e. operating at synchronous speed).

For unit 6, it is a two-pole turbogenerator; therefore, the synchronous speed corresponding to a 50 Hz grid frequency is 3,000 rpm. Small oscillations are also visible in the speed profile after the V411 outage. For better clarity, a zoomed-in view of the generator speed at the time of the V411 outage was also created.

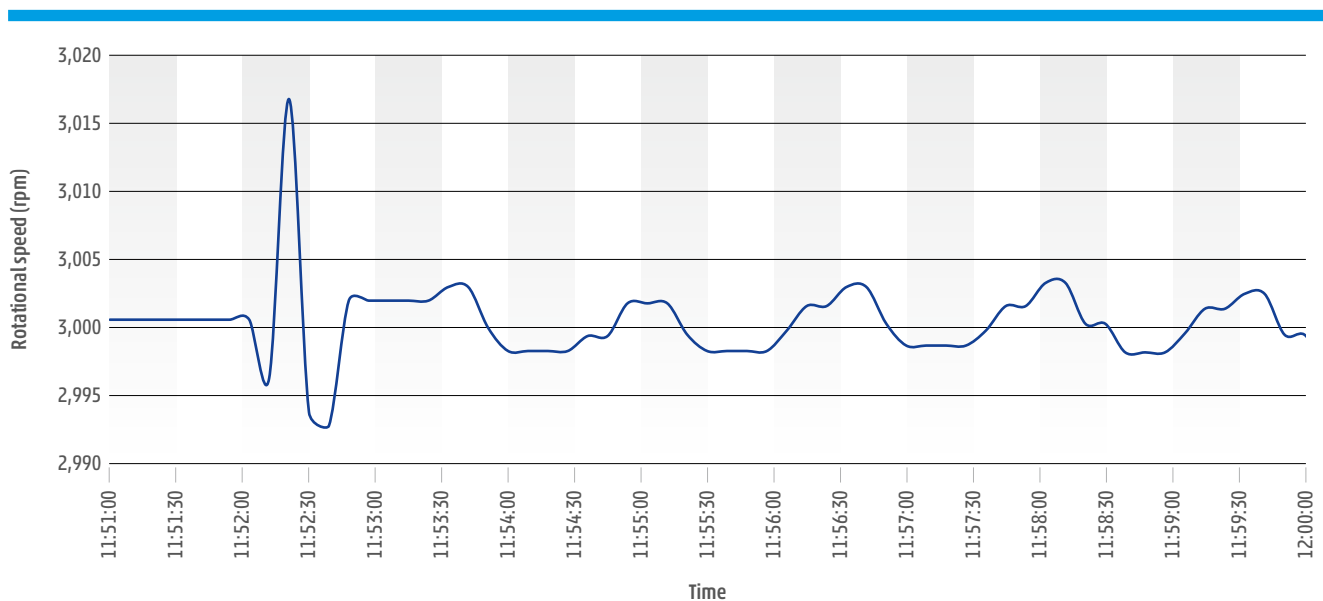
Figure 3.13: Zoomed-in view of speed measurement during the V411 outage

From the speed measurement, it is evident that a transient change was recorded following the outage of line V411, during which the rotor speed reached approximately 3,016 rpm at 11:51:09.

Since a frequency deviation of 200 mHz as a threshold for transition to droop speed control mode corresponds to 12 rpm, unit 6 recorded a deviation greater than the set limit.

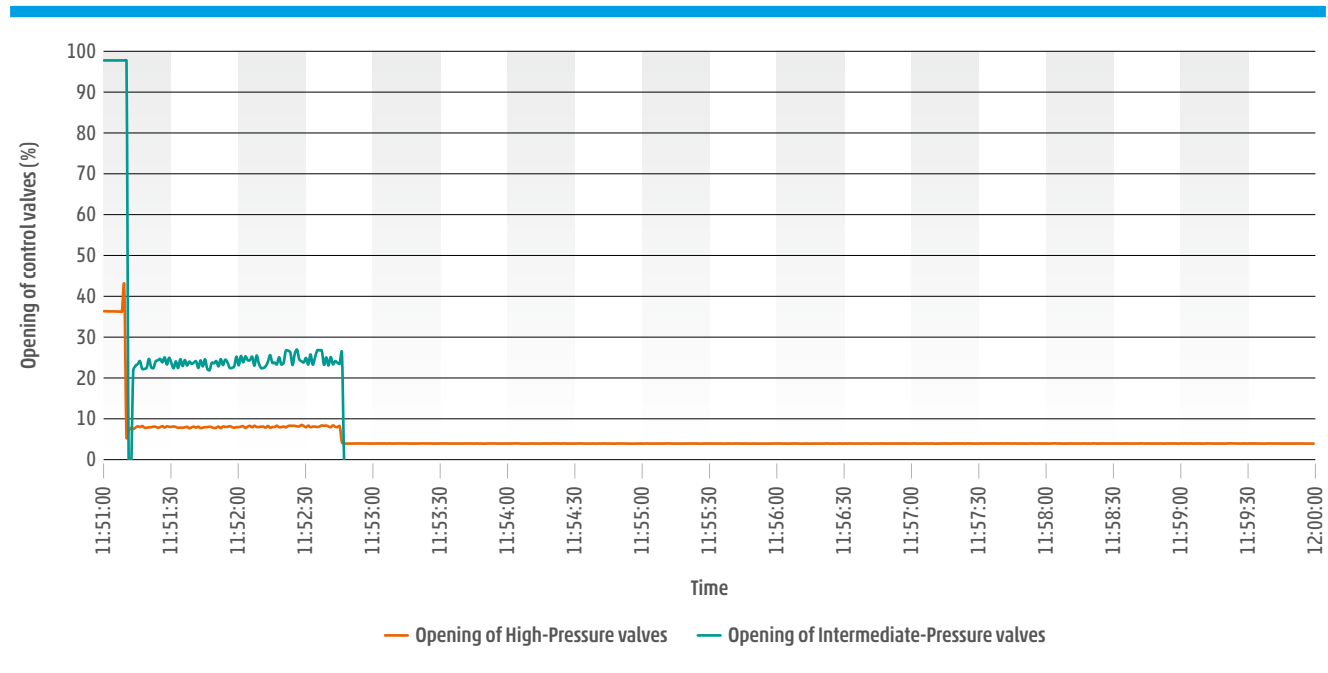
Figure 3.14: Trend of control valves opening for ELED unit 6 from 11:51 to 12:00

The following graphs show profiles of the opening of bypass stations and control valves of TPP Ledvice unit 6. The graphs show that changes in the variables occurred already after the V411 outage.

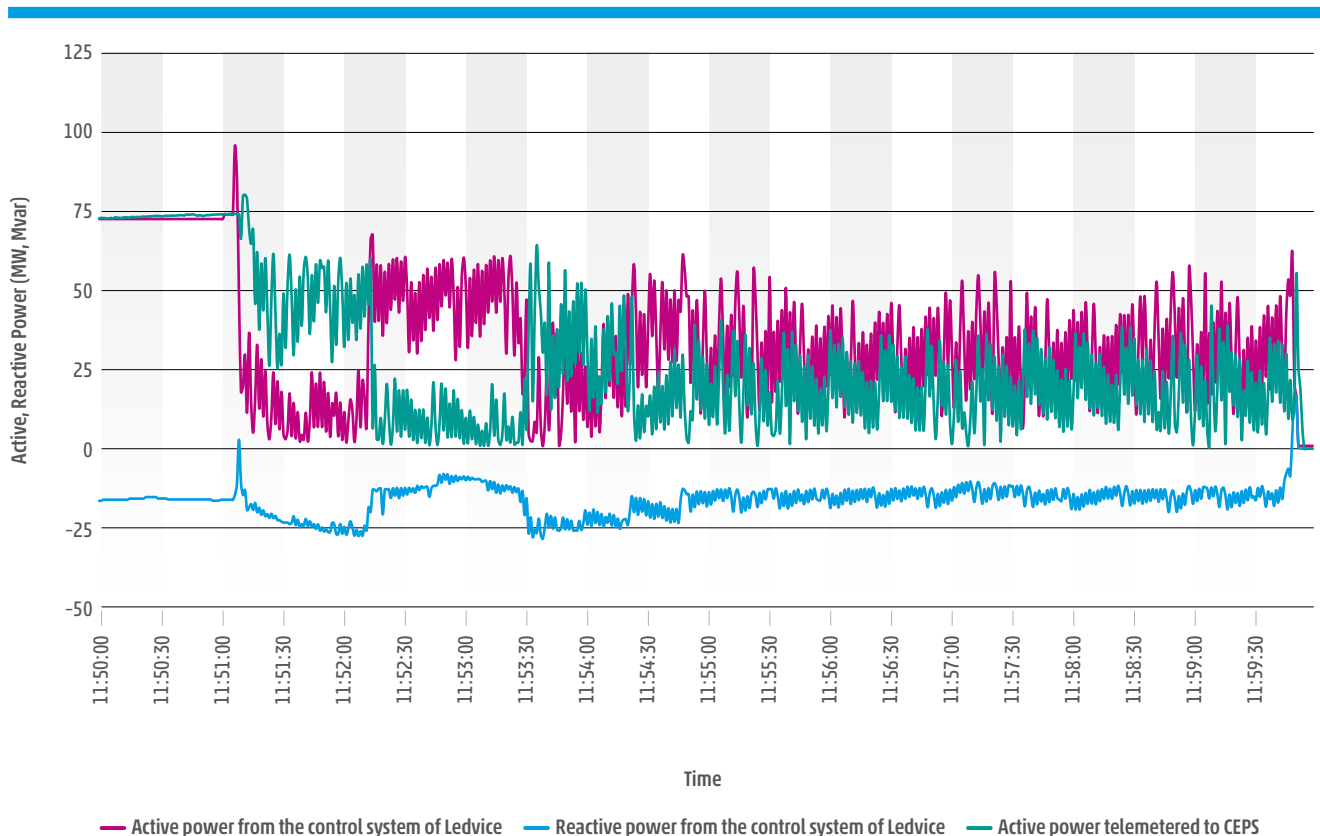
Figure 3.16: Trend of power output at generator terminals of ELED unit 4 from 11:50 to 12:00

Figure 3.16 shows the output of the TPP Ledvice unit 4 generator, again compared with the values from the Ledvice power plant control system and the telemetered values to the ČEPS dispatch control system. From the trends, it is evident that unit 4 experienced oscillations, and the output active power telemetered to the ČEPS dispatch control system differs from the output power recorded in the power plant control system. Therefore, it is also more difficult to calculate the total loss of active power generation after the V411 outage.

According to the power plant statement, unit 4 of TPP Ledvice had a droop setting of 0% in droop speed control mode, meaning that the proportional speed controller's gain was theoretically infinite. Such a gain would theoretically mean that, for any positive frequency deviation from 50 Hz, the unit would drop to zero active power, and for any negative deviation, it would go to its maximum available output. The gain is limited in practice by the mechanical equipment's capabilities. In accordance with information provided by the power plant, this droop setting does not seem to be in line with the expected performance.

It should also be noted that, according to the Transmission System Grid Code, the droop setting for IOCM should be in the range of 4–10%. However, unit 4 of TPP Ledvice is not certified for IO capability as an ancillary service, as it is connected to the distribution system. ČEPS does not procure this service from units connected to the distribution system, which also implies that the unit is not subject to regular certification for IO capability, as are units providing this service in the transmission system.

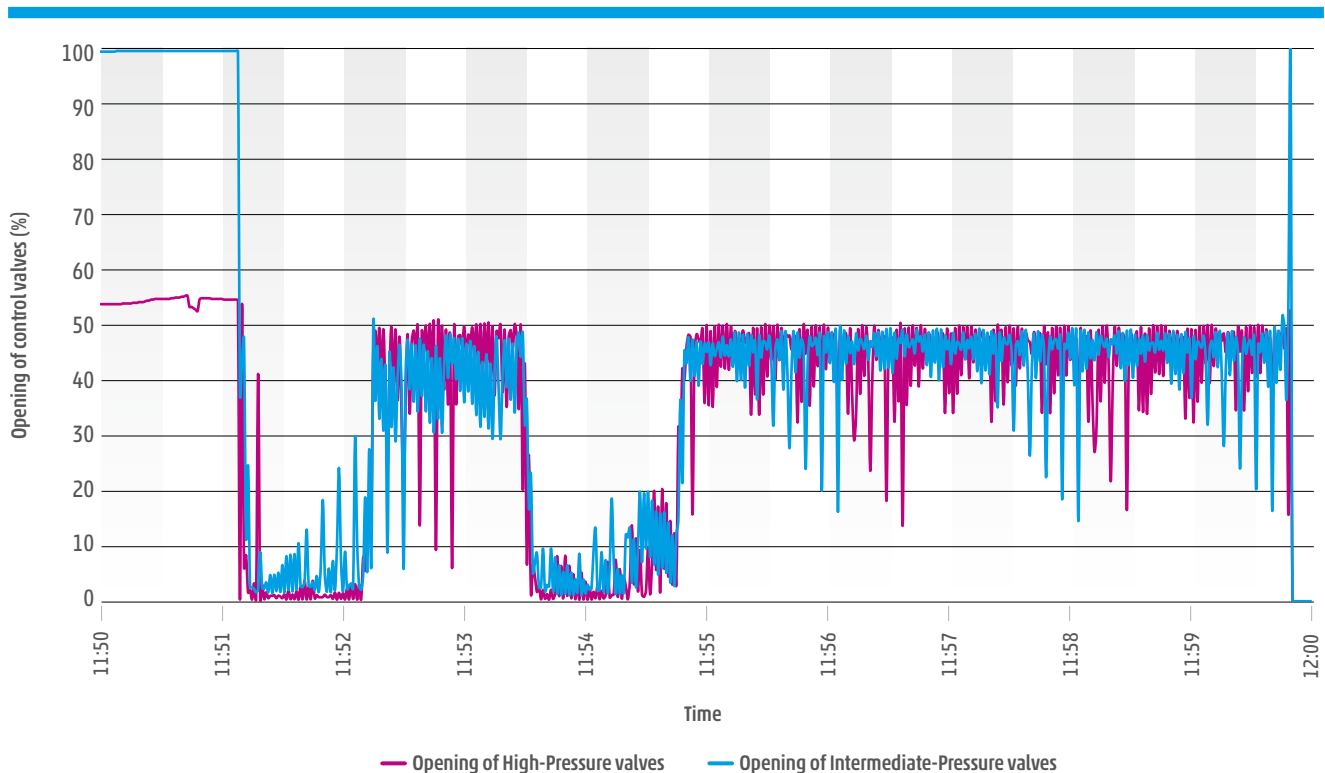
Figure 3.17: Trend of control valves opening for ELED unit 4 from 11:50 to 12:00

Oscillations are also evident in the opening of the turbine control valves on TPP Ledvice unit 4 following the V411 trip and the switch to droop speed control mode.

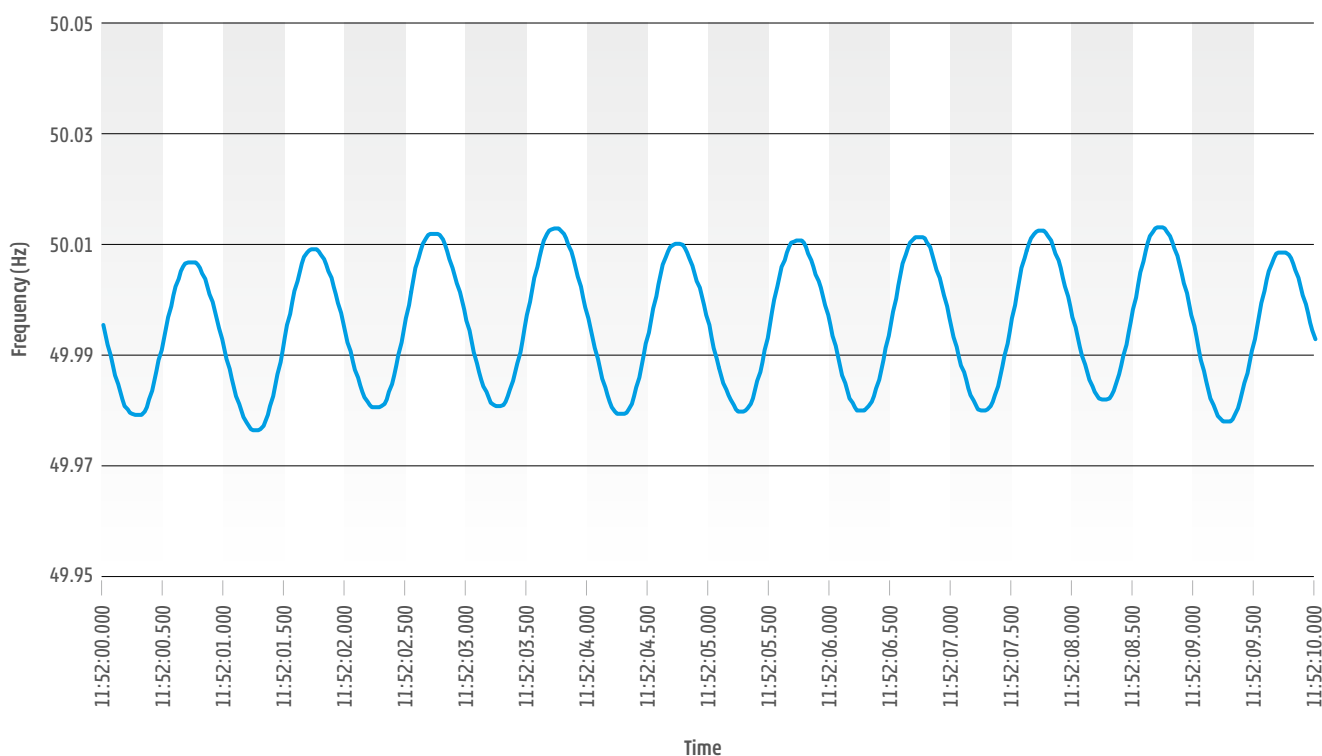
Figure 3.19: Zoomed-in view of the WAMS frequency measurement at the CST substation in the V400 line bay

Although the frequency value stabilised around the nominal value 50 Hz after the disconnection of line V411 – since the affected part of the grid remained synchronously connected to the surrounding system – frequency oscillations are still visible. Figure 3.19 therefore shows a zoomed-in view of the frequency measurement over a 10-s interval, revealing ongoing oscillations with a period of approximately 1 s with a peak-to-peak amplitude of 30 mHz.

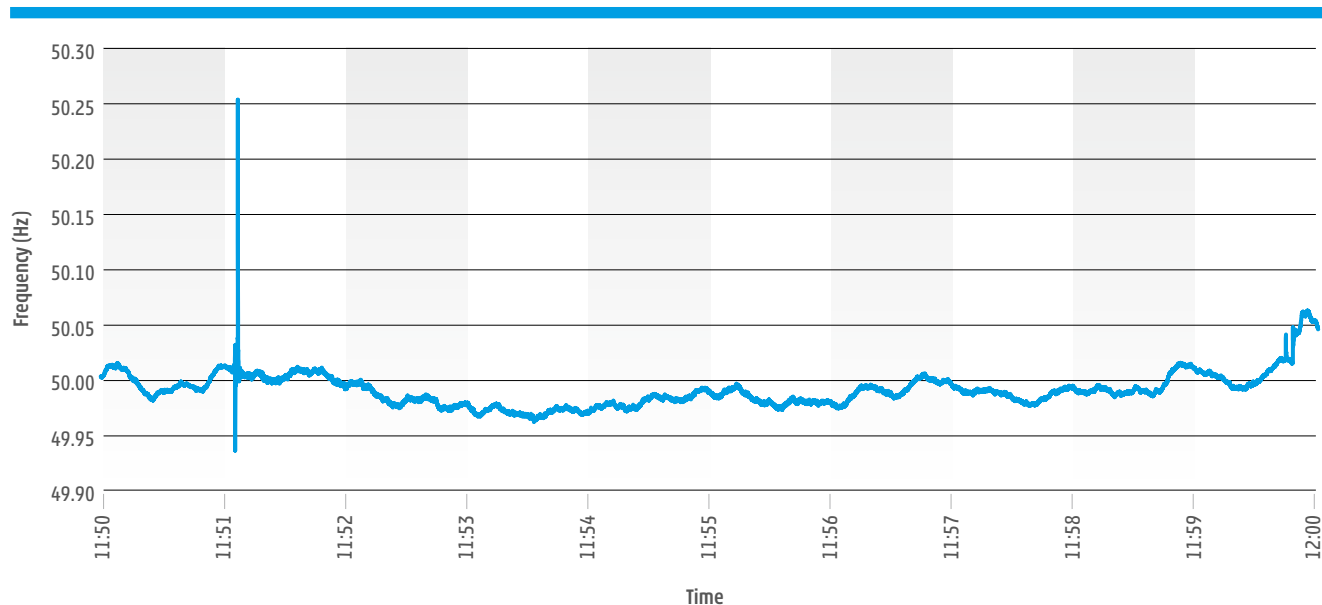
Figure 3.20: WAMS frequency measurement at the HRA substation in the V412 line bay from 11:50 to 12:00

This oscillation was observed only in the area (at least according to available WAMS measurements) that was subsequently affected by a voltage outage. The graph below shows frequency measurements from the Hradec substation, which the V411 line connects to. The data is taken from the V412 Hradec–Řeporyje line bay.

In this waveform, oscillations following the V411 outage are not visible. Furthermore, the frequency measurement from the Hradec substation clearly shows that a frequency deviation greater than 200 mHz was recorded during the V411 line outage, representing the WAMS measurement closest to the V411 line.

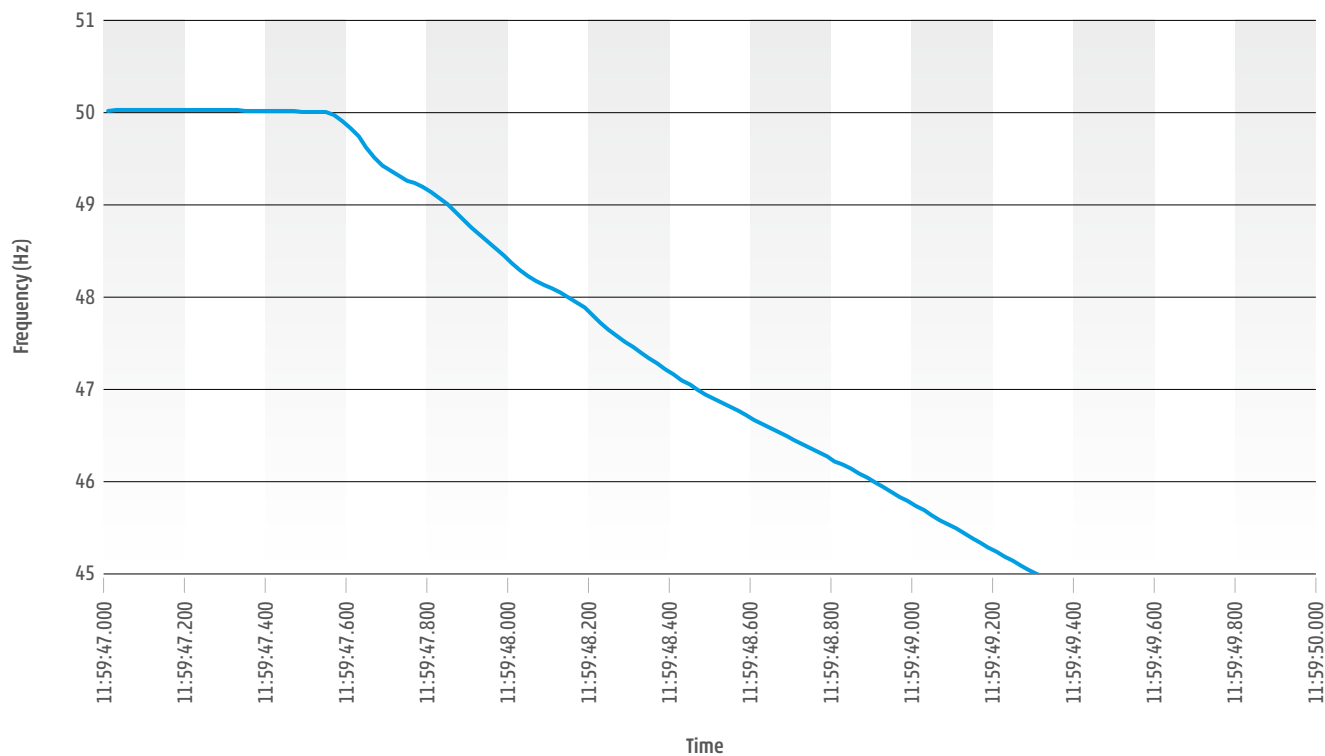
Figure 3.22: Recorded frequency collapse in the WAMS frequency measurement at the CST substation

As mentioned above, the WAMS measurement in the area affected by the voltage outage is installed at the Čechy Střed substation. The following course of the frequency collapse of the already-formed deficit island after the Krasíkov busbar coupler was switched off at 11:59:47 is also taken from this measurement.

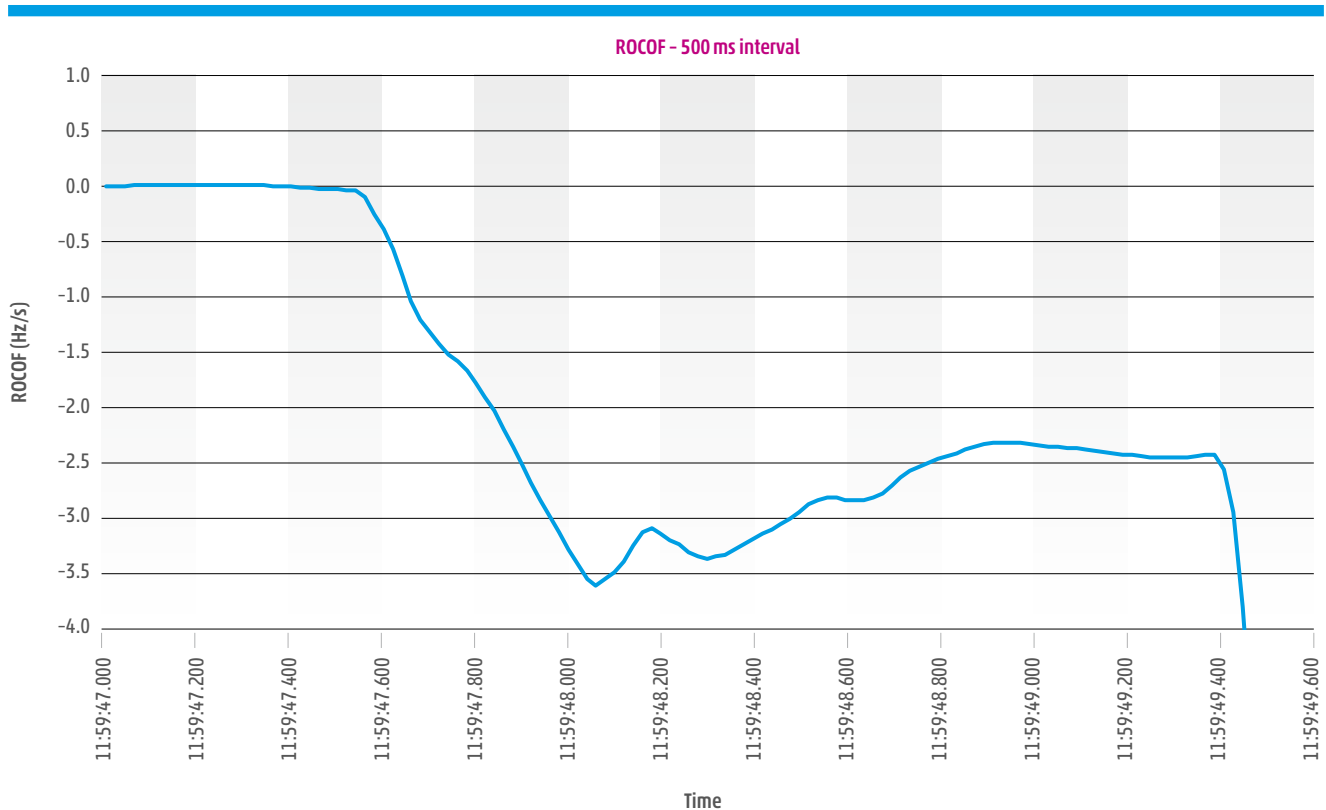
Figure 3.23: RoCoF profile during the frequency collapse

The RoCoF value during the frequency collapse is shown in Figure 3.23. The highest recorded RoCoF value was around  $-3.5$  Hz/s.

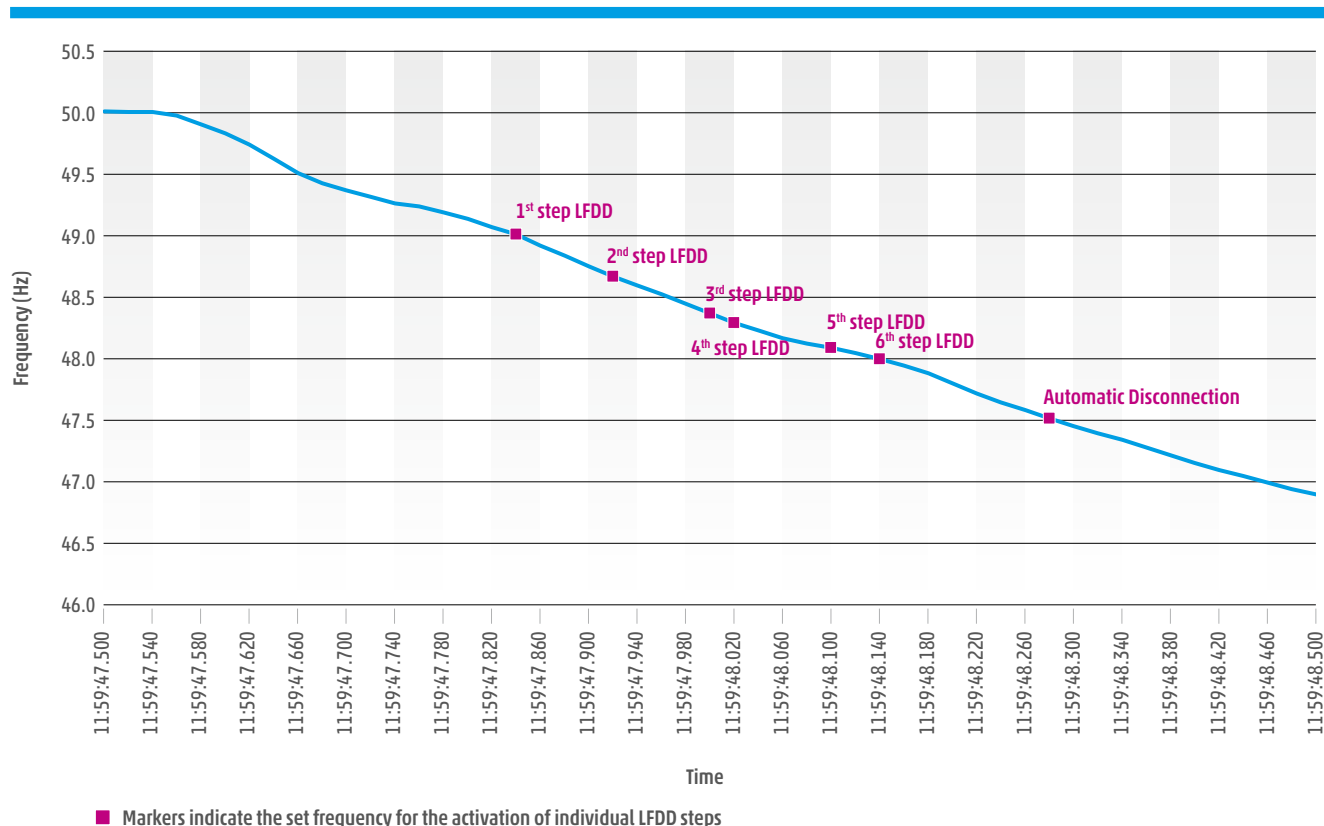
Figure 3.24: Frequency profile during the frequency collapse with indication of the set limits for LFDD steps

Due to the significant deficit – estimated at approximately 1,800 MW based on the power flow through the busbar coupler at the Krasíkov substation at the time of its disconnection – and the resulting high RoCoF of the IO

even the activation of LFDD was insufficient to prevent the final collapse. Figure 3.24 illustrates the expected activation sequence of individual LFDD steps.

The graph clearly shows that due to the rapid frequency drop, there was insufficient time to activate all LFDD steps. The Synchronous Area Framework Agreement for Regional Group Continental Europe<sup>20</sup> requires the load to be disconnected within 300 ms. During the incident, only steps 1 and 2 were disconnected before the point of disconnections of all PGMs (at 47.5 Hz) in the island was reached.

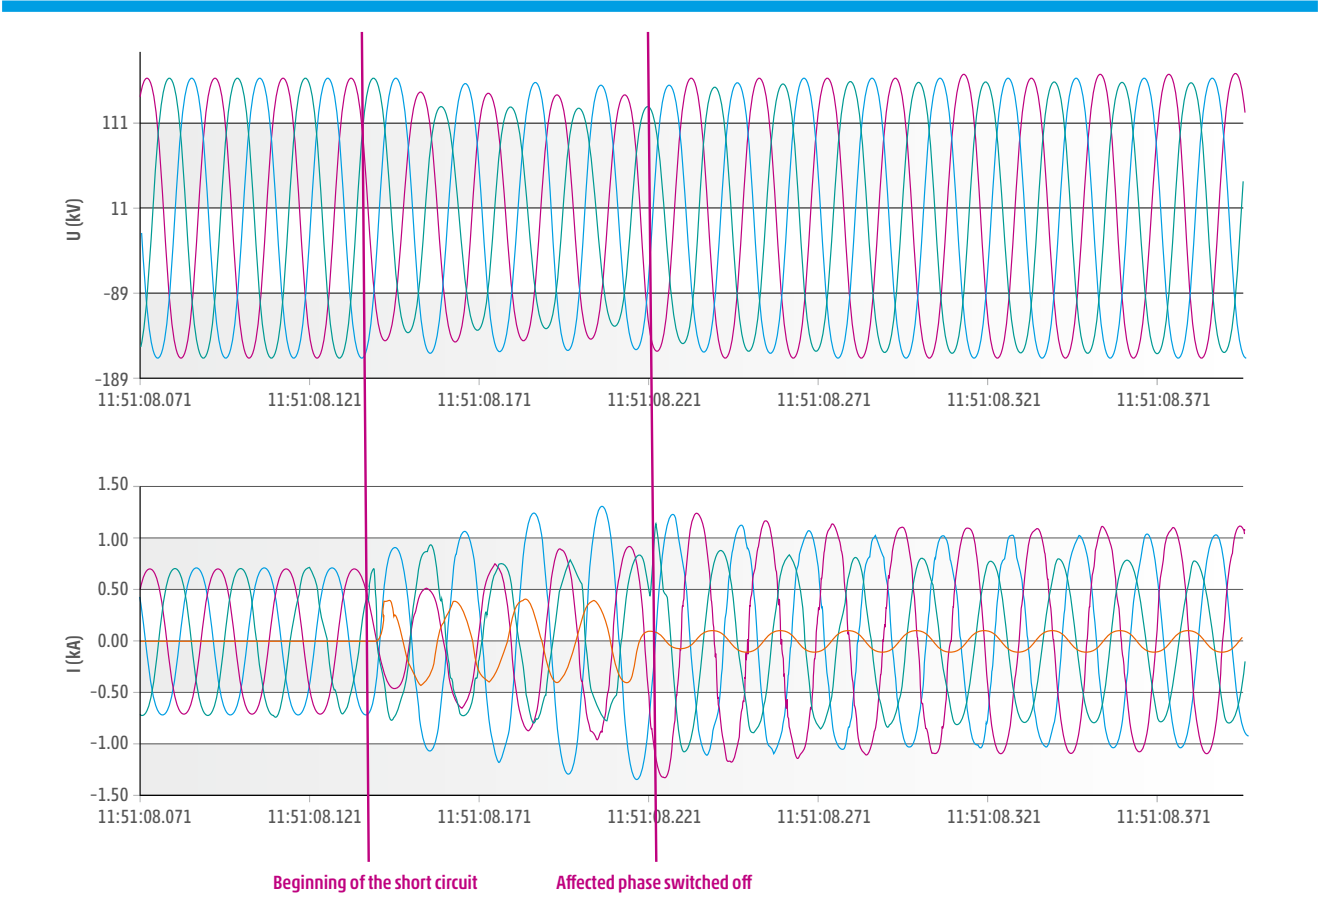
Figure 6.4: Measurements from the quality meters on the 110 kV side of the T401BEZ transformer at the beginning of the short circuit

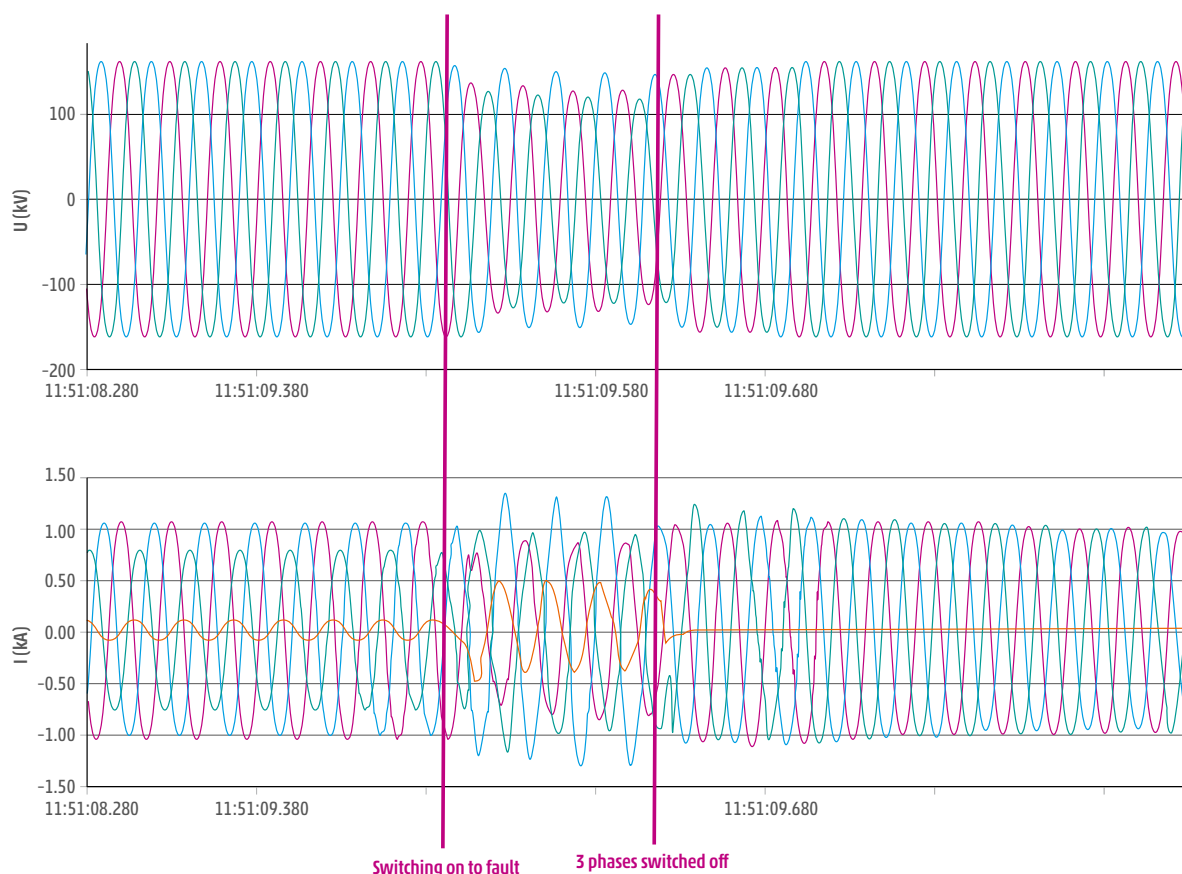
Figure 6.5: Measurements from the quality meters on the 110 kV side of the T401BEZ transformer until 3 phase tripped

This measurement shows that on the 110 kV side of the T401BEZ transformer, the voltage in none of the three phases dropped below 100 kV during the entire fault period (i.e. during the initial one pole short circuit, during the single-pole auto-recloser or during the switch to the fault).

Since the measurement location is physically closer to the location of the initial fault itself, it can be evaluated that the voltage drop observed at the connection point of the PV did not exceed FRT limits.

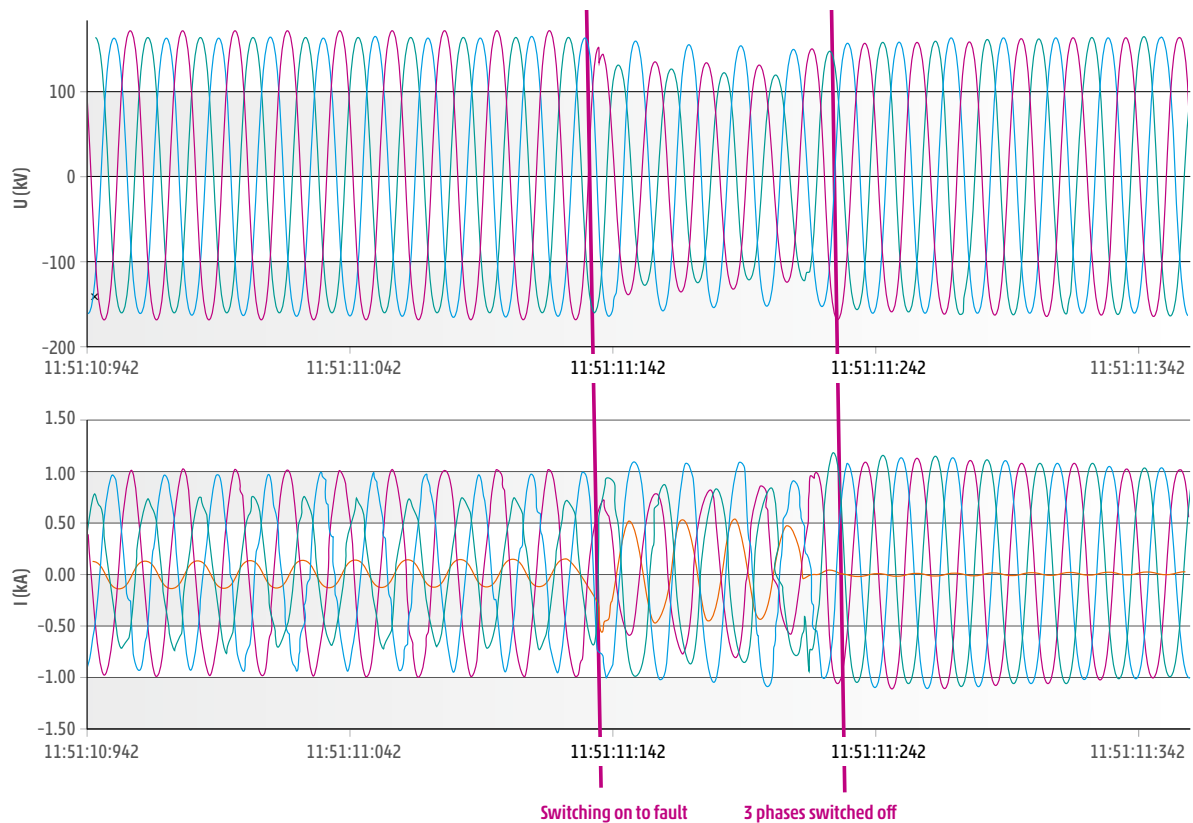
Figure 6.9: Measurements from the quality meters on the 110 kV side of the T403CST transformer until 3 phases tripped

Since the measurement location is physically closer to the location of the initial fault itself, it can be evaluated that the voltage drop observed at the connection point of PV B did not exceed FRT limits.

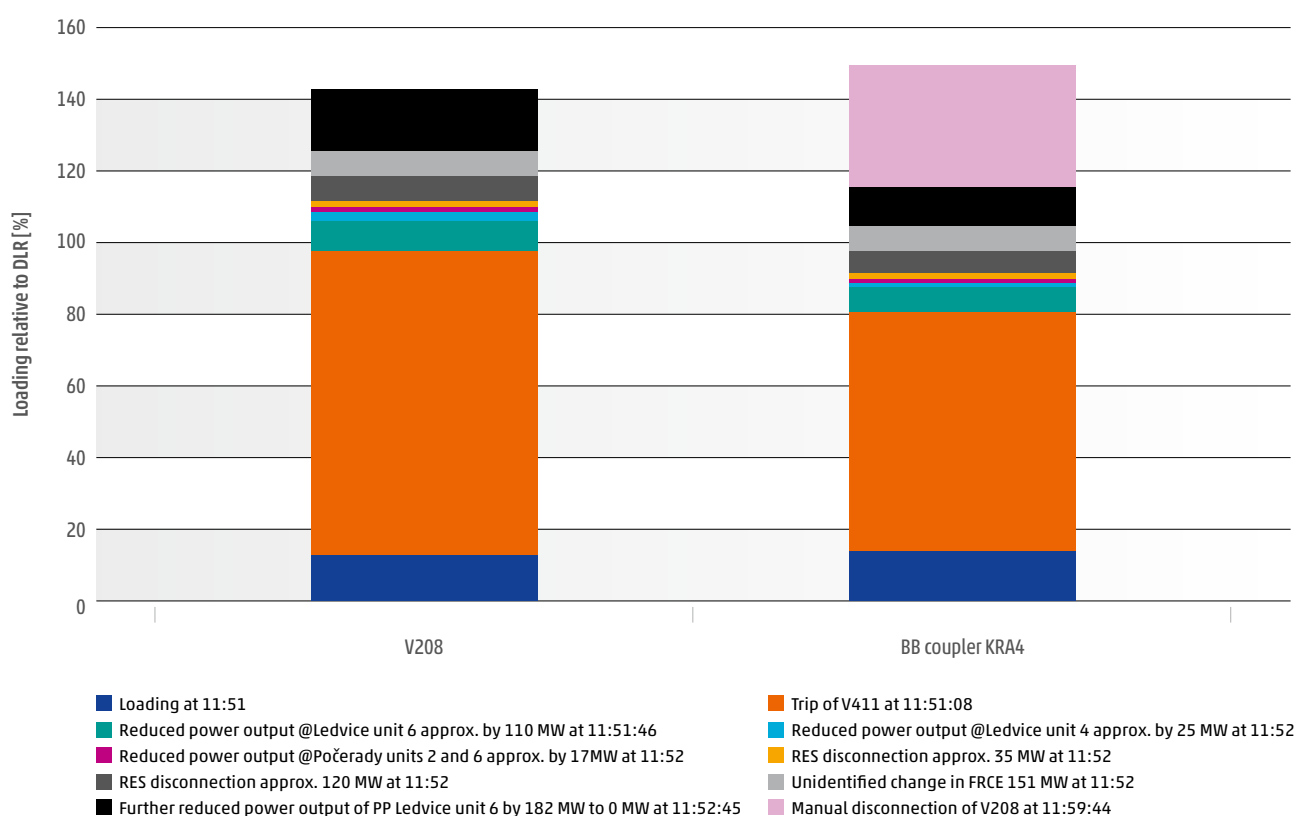
led to a severe overload of V208, reaching up to 142%. After that, the line V208 was disconnected, marking the point of no return (as described in the fault tree).

Figure 8.1: Decomposition of the loading of the line V208 and the busbar coupler at Krasíkov
